SUPERALLOY KNIFE EDGE SEAL REPAIR

GENERAL ELECTRIC COMPANY
CINCINNATI, OHIO 45215

MAY 1978

TECHNICAL REPORT AFML-TR-78-56
Final Report for period 1 March 1976 to 31 November 1977

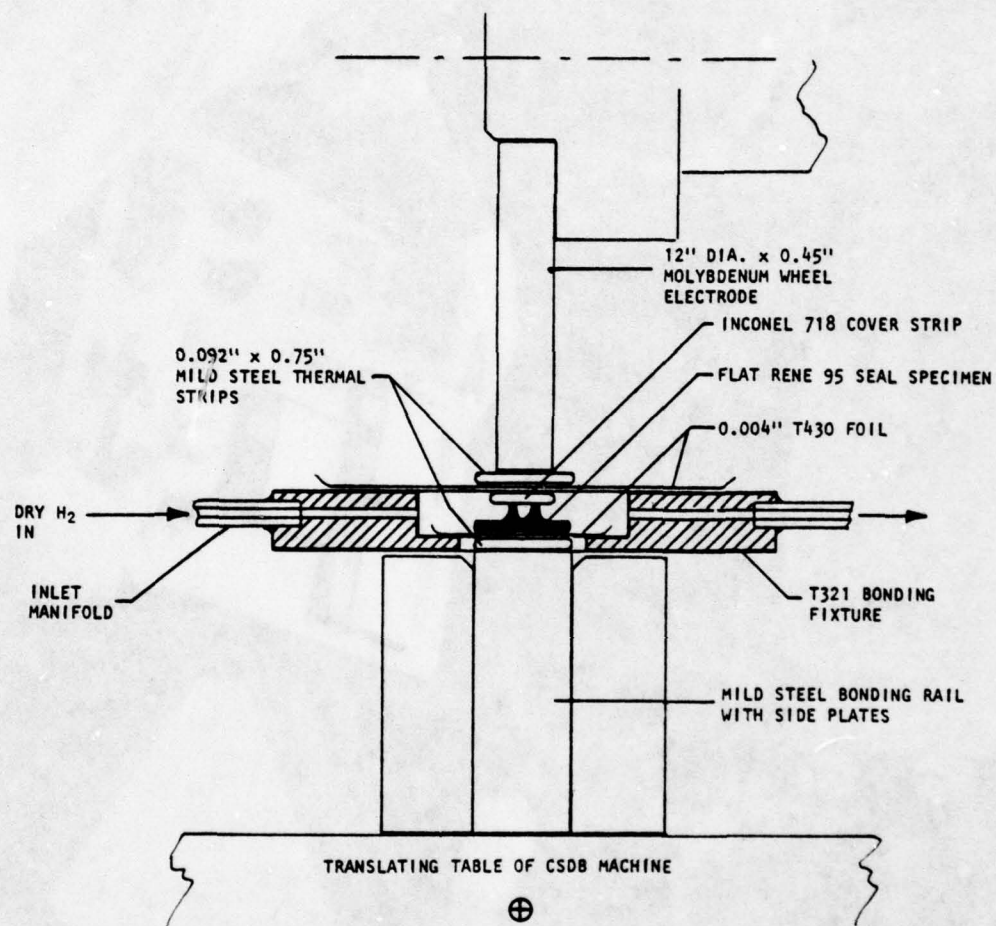
Figure 26. Cross Section of Bonding Lay-Up For CSDB of Flat Seal Teeth Bars.

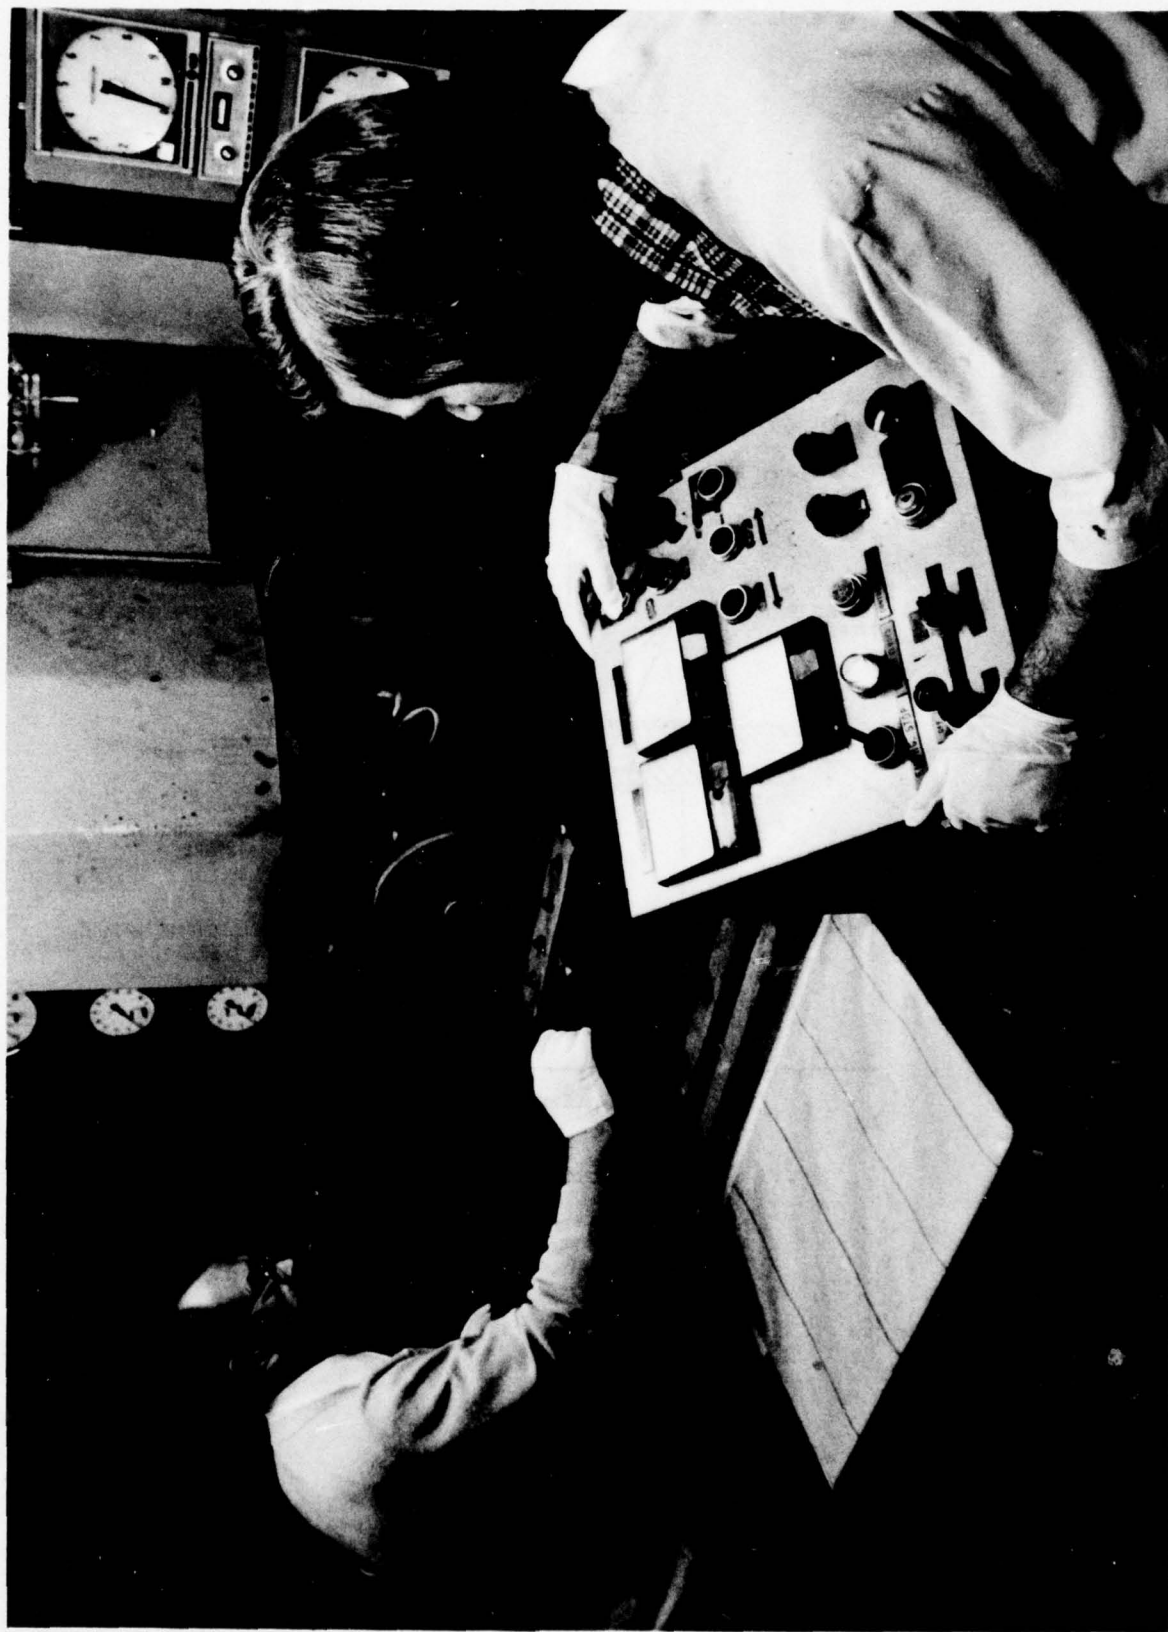
Figure 27. Simulated CSDB of Flat Seal Teeth Bar Samples in CSDB Machine.

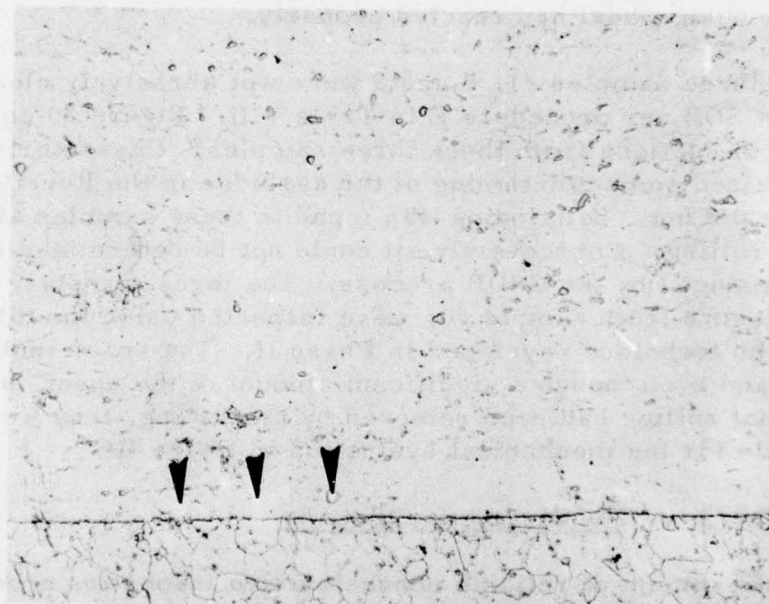
Top: End Closer

Bottom: Longitudinal Section Through Cover Strip.

Figure 28. End Closure For Flat Seal Teeth Bars.

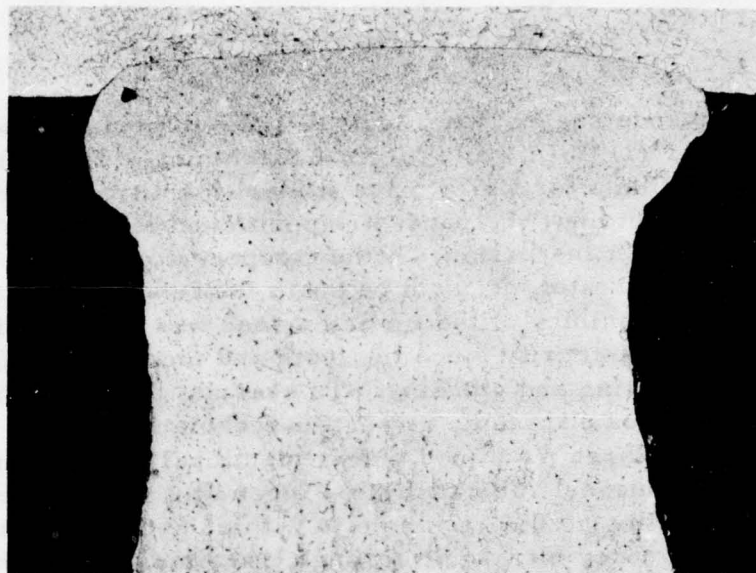
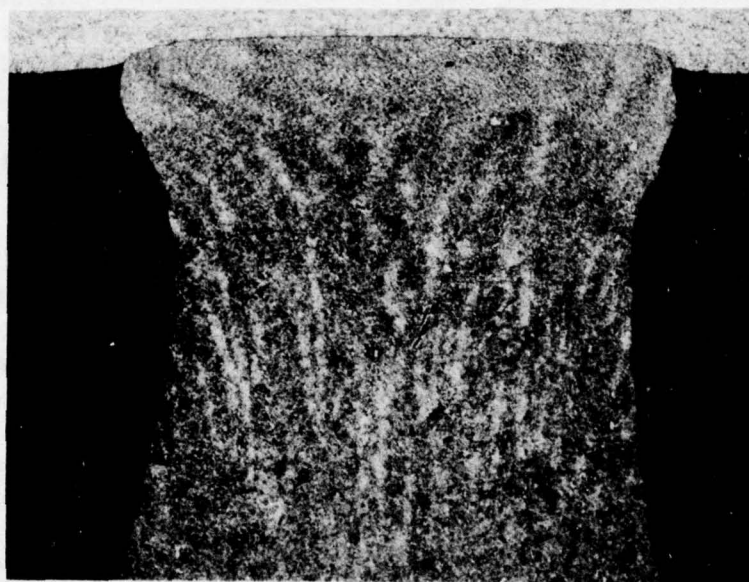
Figure 29. Sections Through Flat Seal Teeth Bars For Mechanical Evaluation.

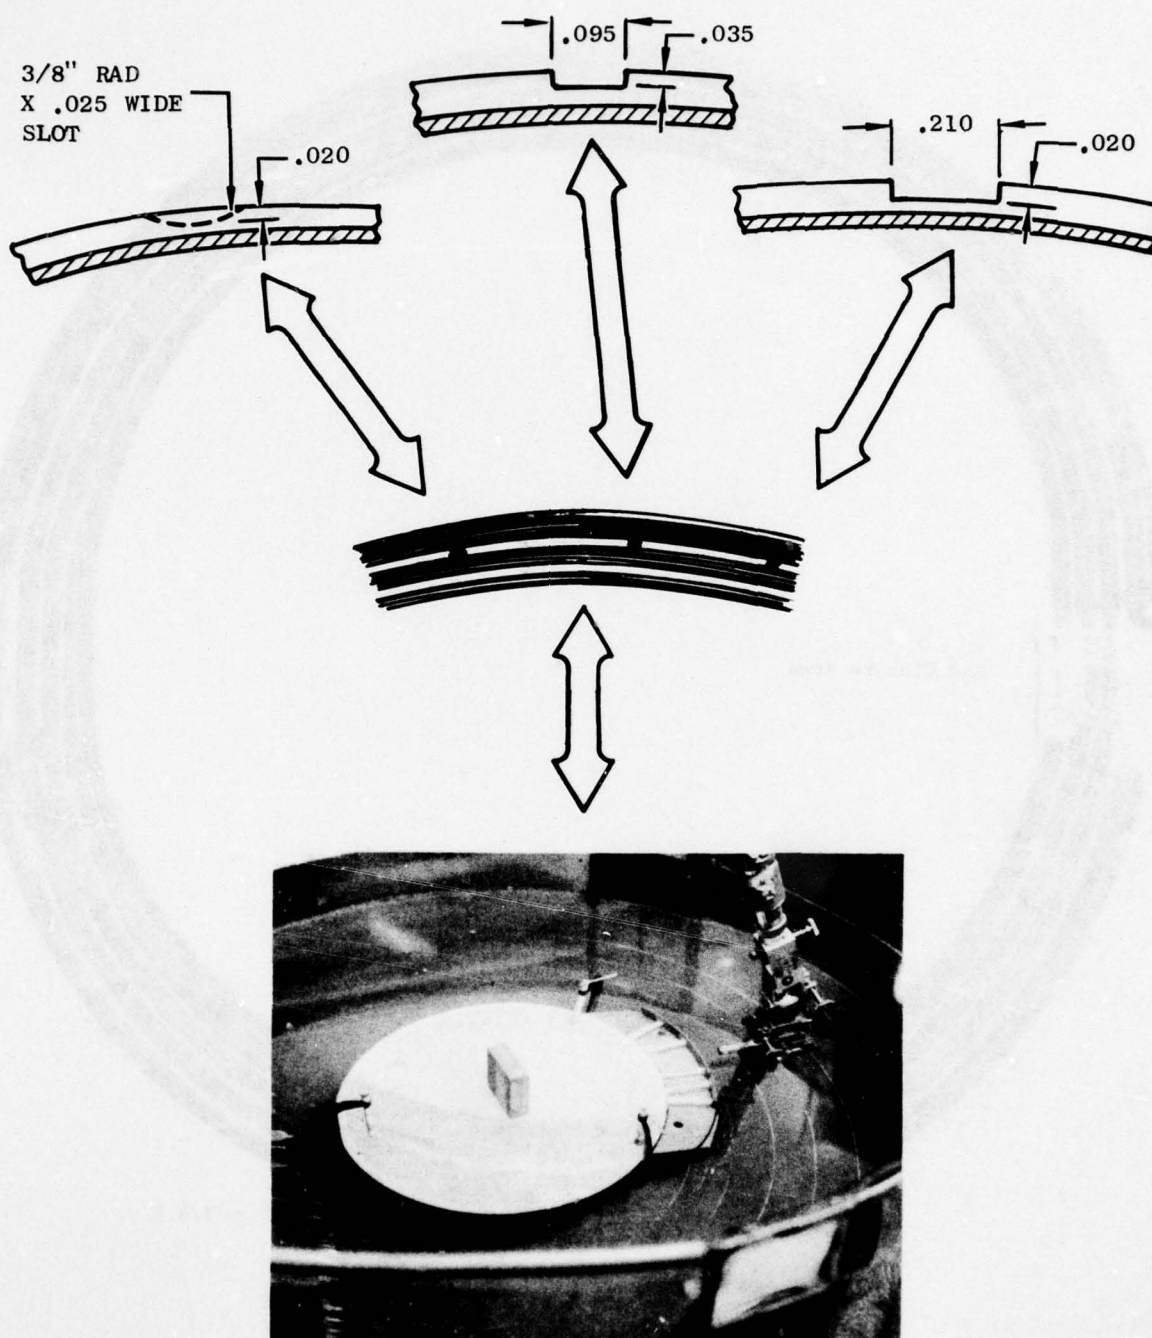
Figure 30. Ultrasonic Pulse-Echo Set-Up, Prelocated Defects and C-Scan of Prelocated Defects.

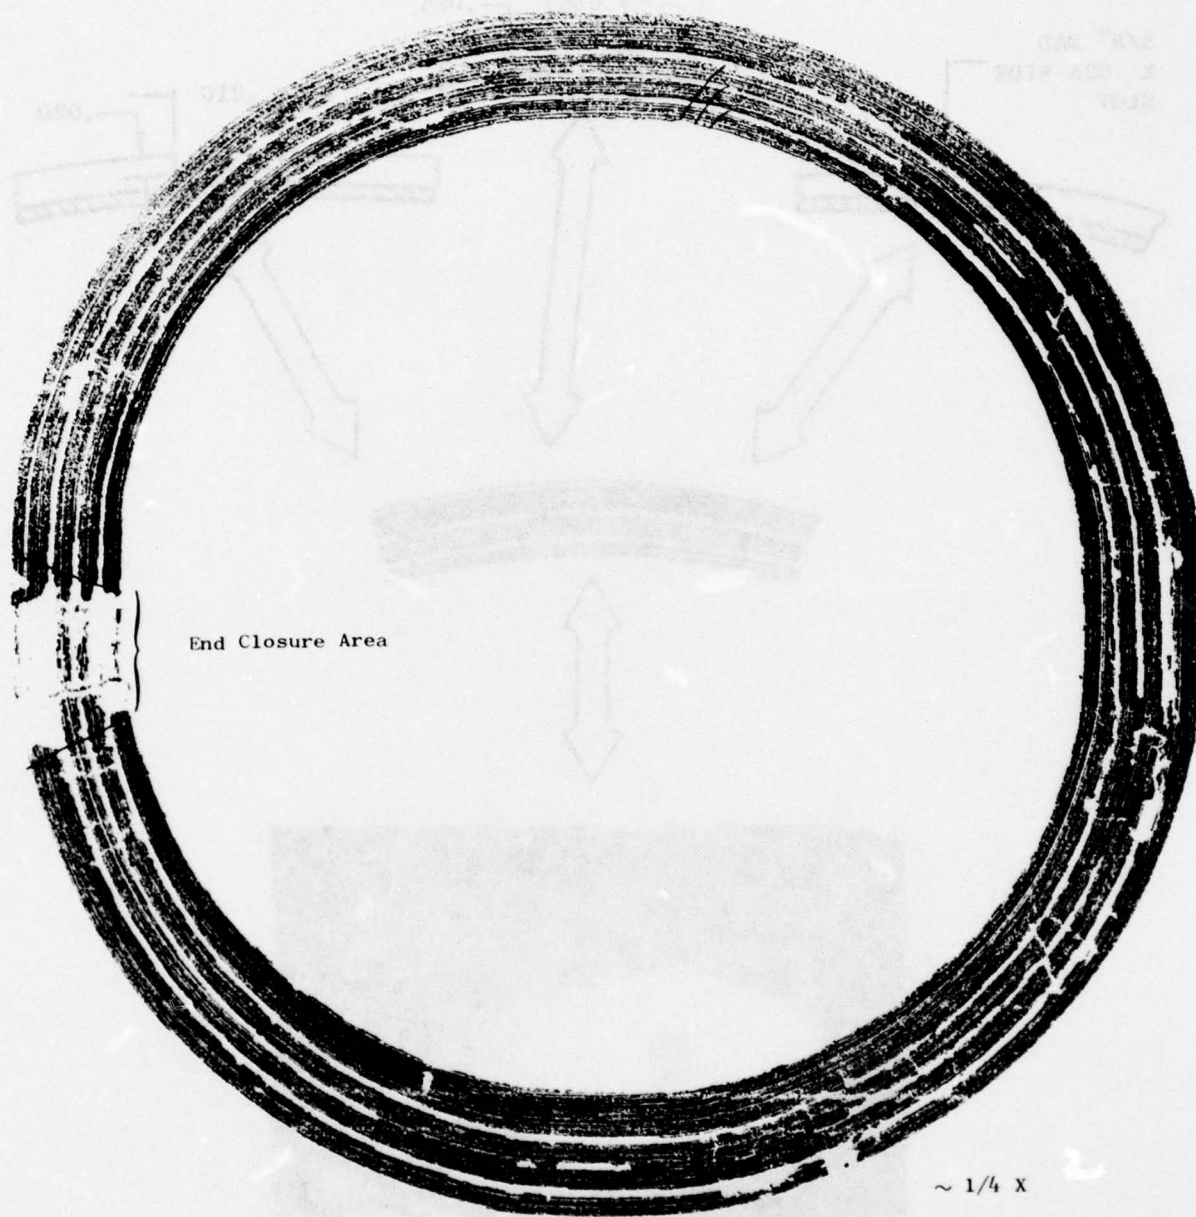
Figure 31. Ultrasonic Pulse-Echo C-Scan of Seal Ring #3.

Note: White Lines Indicate Bonded Areas

The quality of the bonds in the end closures of seal rings #3 and 5 was undeterminable by NDT because of roughness of the top surfaces. This is shown in Figure 31. A trial closure from seal ring #2 was scanned with the pulse-echo technique prior to its being sectioned.

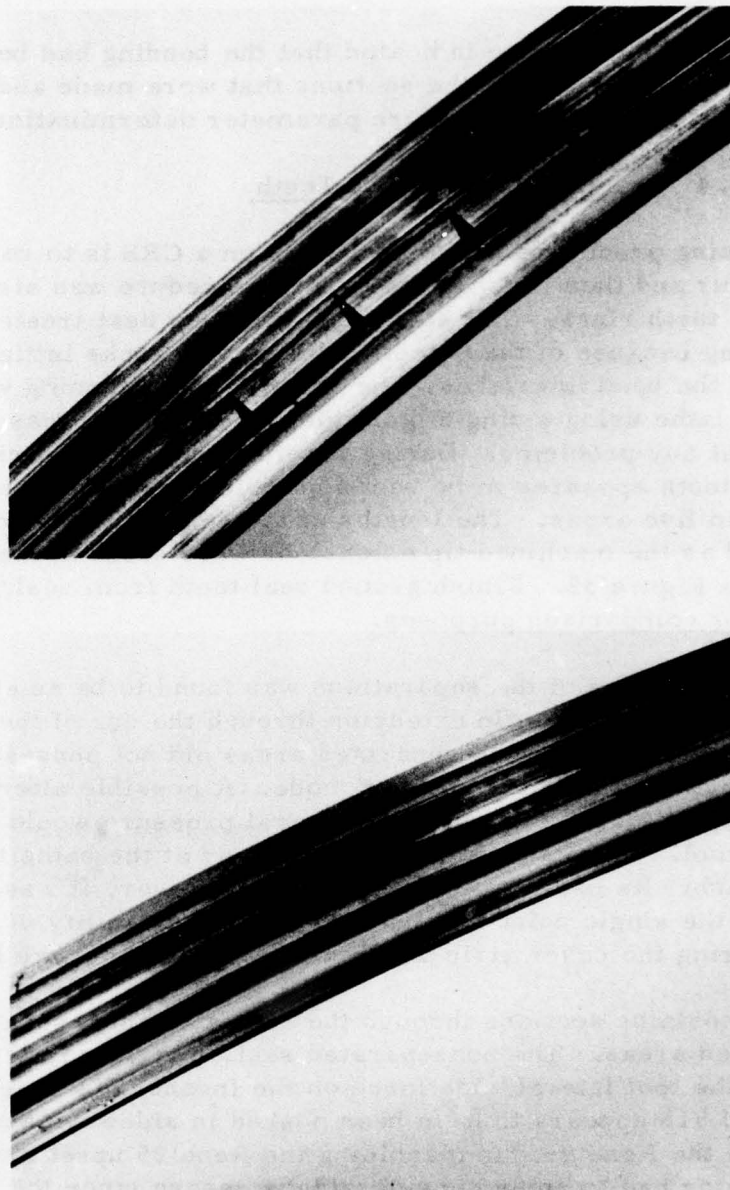
Figure 32. Seal Teeth Rings After Reprofiling.

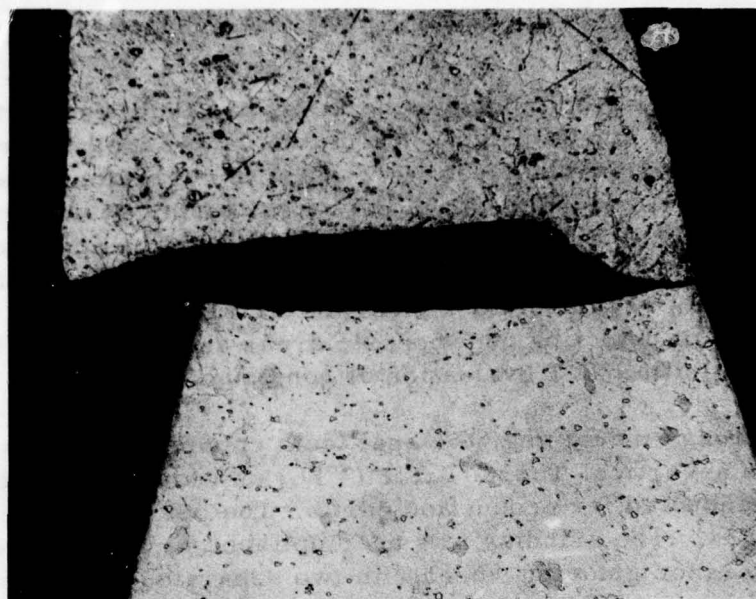
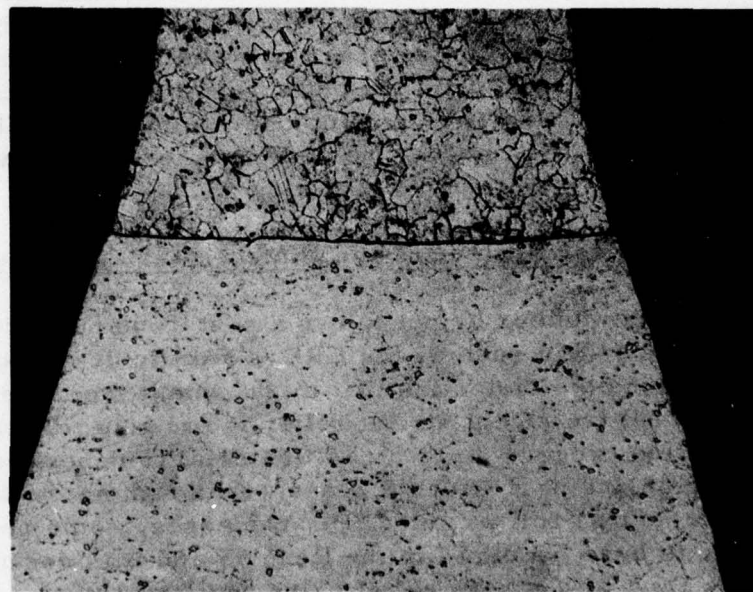
Note: Arrows Indicate Separated Length

Figure 33. Sections Through Center Tooth of Seal Ring #3.

Figure 33 contains sections through the center tooth in separated and nonseparated areas. The nonseparated section vividly illustrates the results of the tool lateral/side force on the Inconel 718 tip extension. The Inconel 718 appears to have been pushed in sideways and is not in line with the Rene'95. In machining the Rene'95 upset area, the lathe operator had to apply considerable pressure since the Rene'95 was more difficult to machine than the Inconel 718. As the single point tool started to machine the Inconel 718, the resistance to tool pressure was reduced and it cut deeper, but the operator could not compensate fast enough. Other than possible contamination on the bonding surfaces, no reason could be found for the weakness in this particular bond. A good diffusion bond is obviously necessary to withstand the rigors of the reprofiling operation.

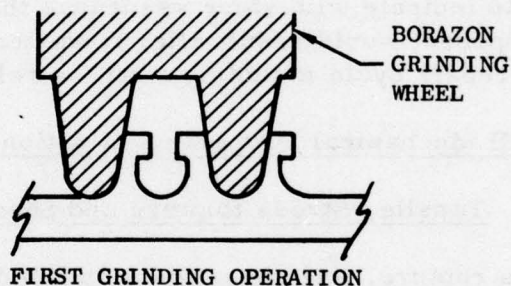
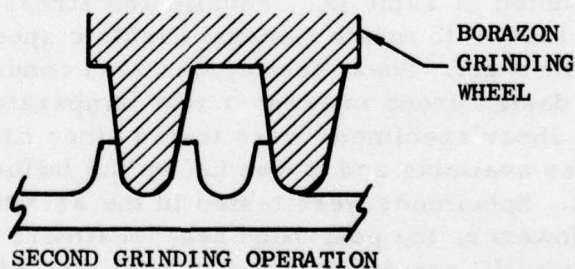
Figure 34. Pictorial Representation of Machining of Seal Teeth From Cover Strip.

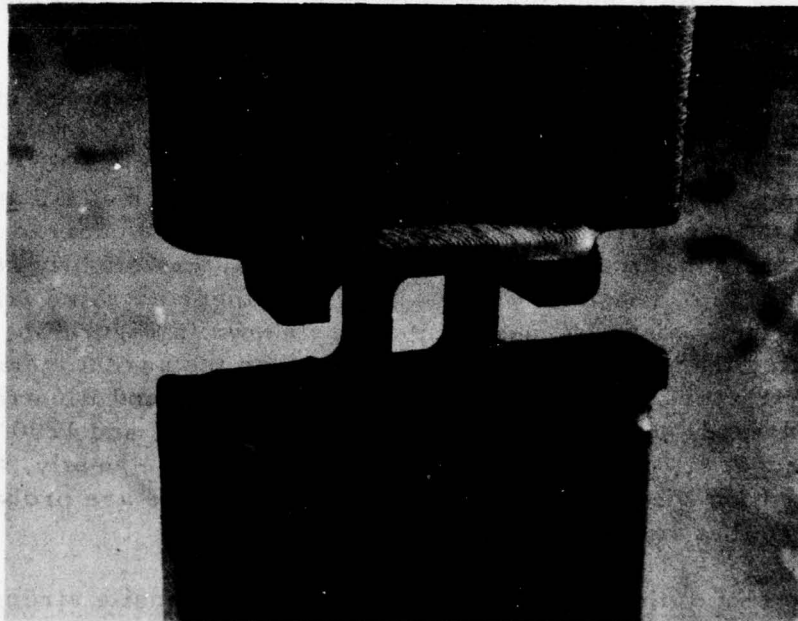
Figure 35. Tensile and Stress Rupture Specimen

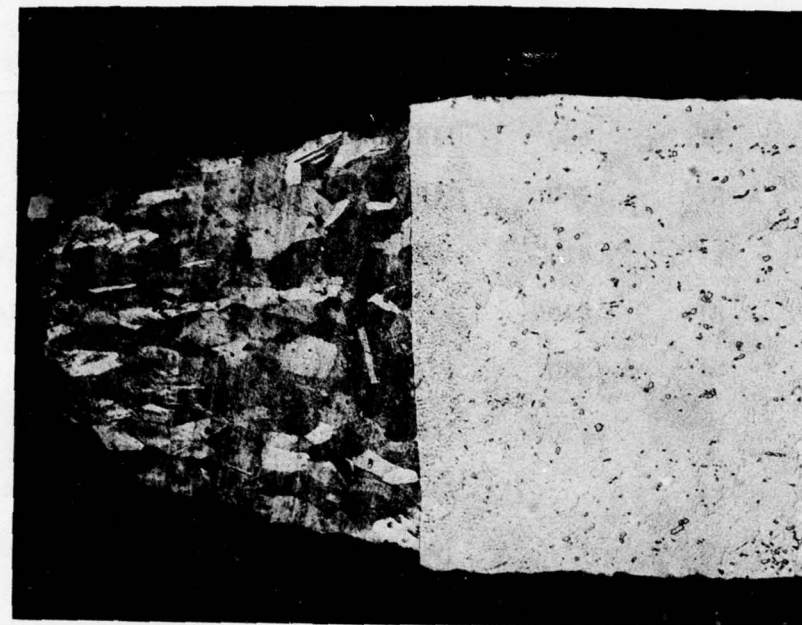
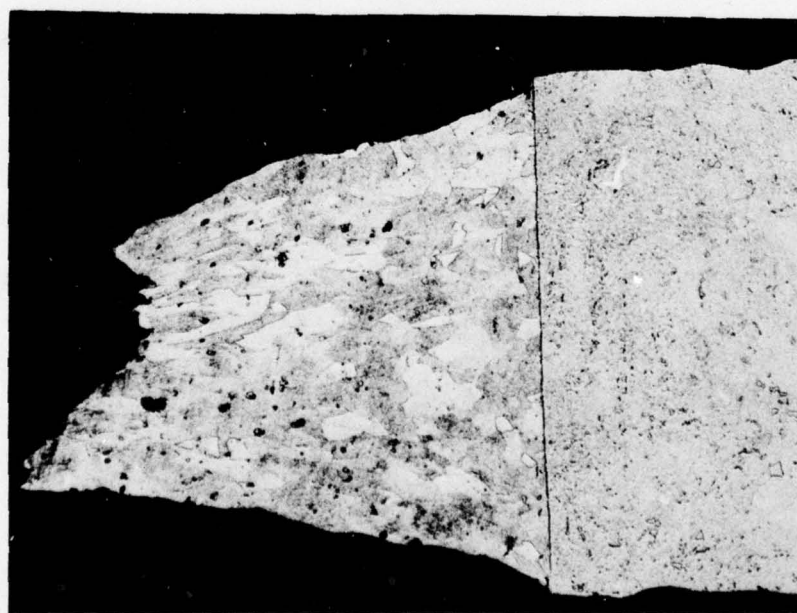
Figure 36. Room Temperature Failures in As-Bonded Tensile Specimen.

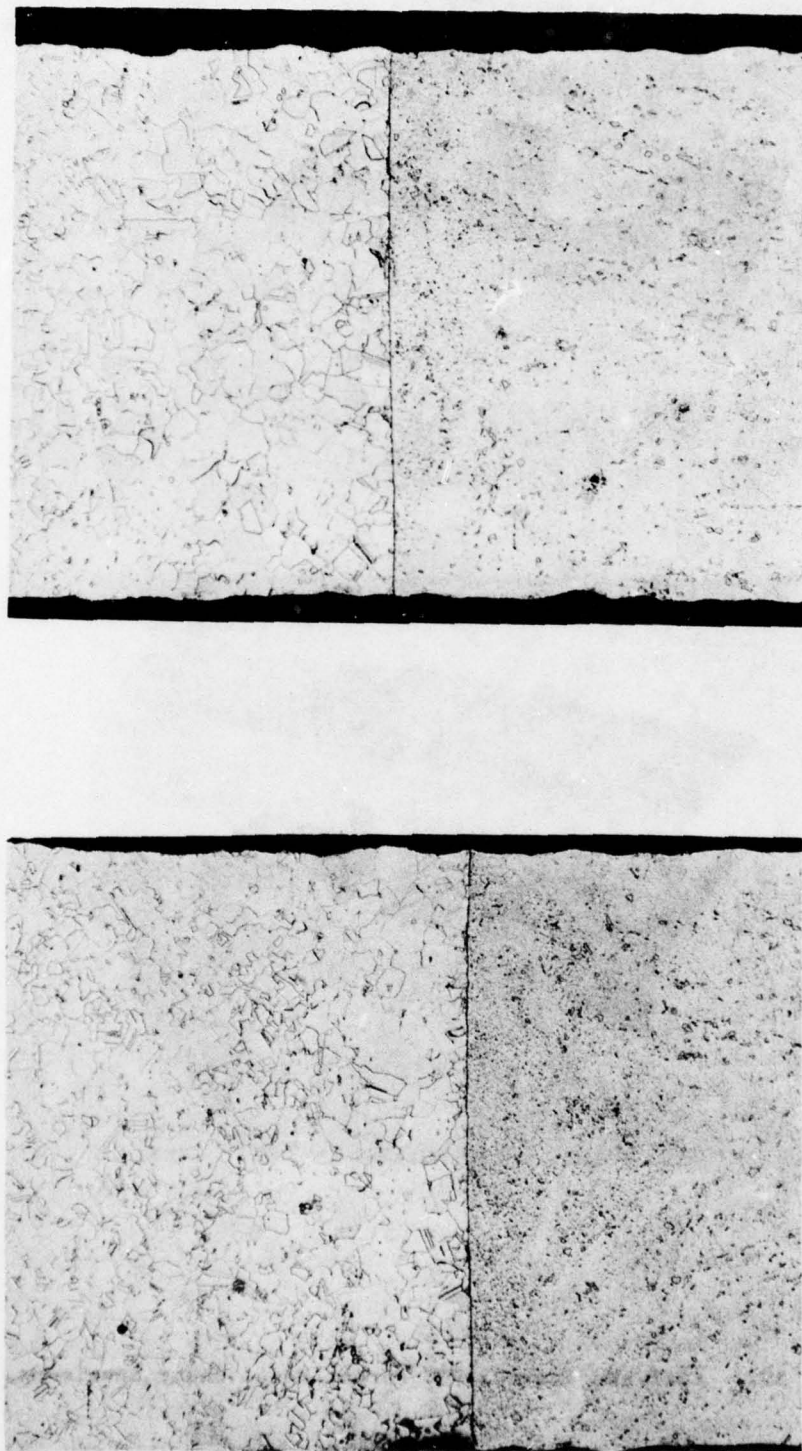
Figure 37. Bond Areas of Stress Rupture Specimen #9.

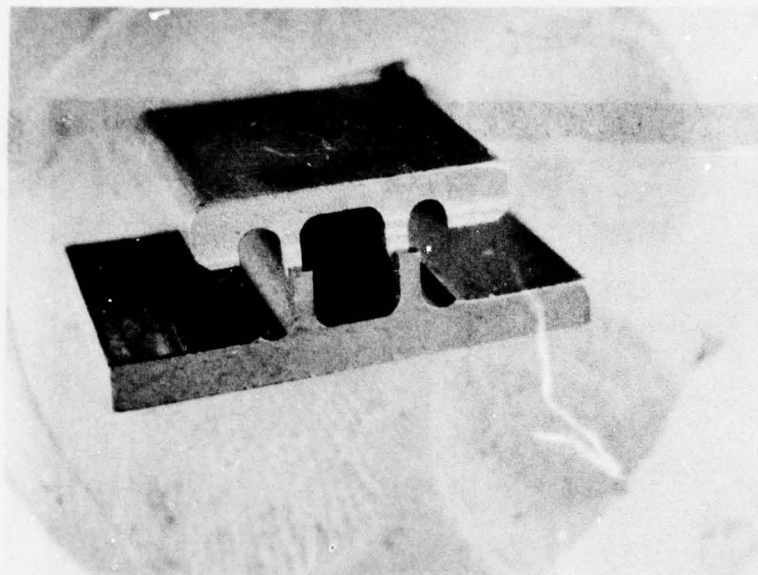
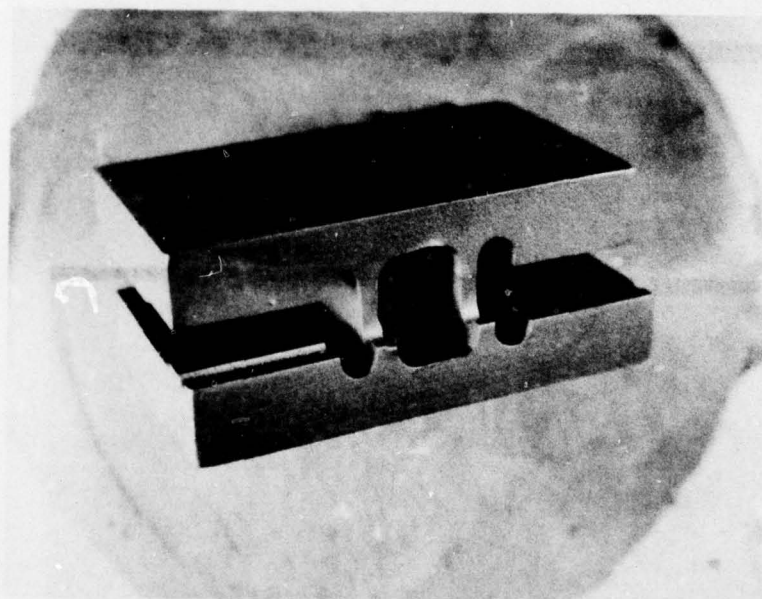
Figure 38. CSDB and Inconel 718 Parent Metal Shear Specimens.

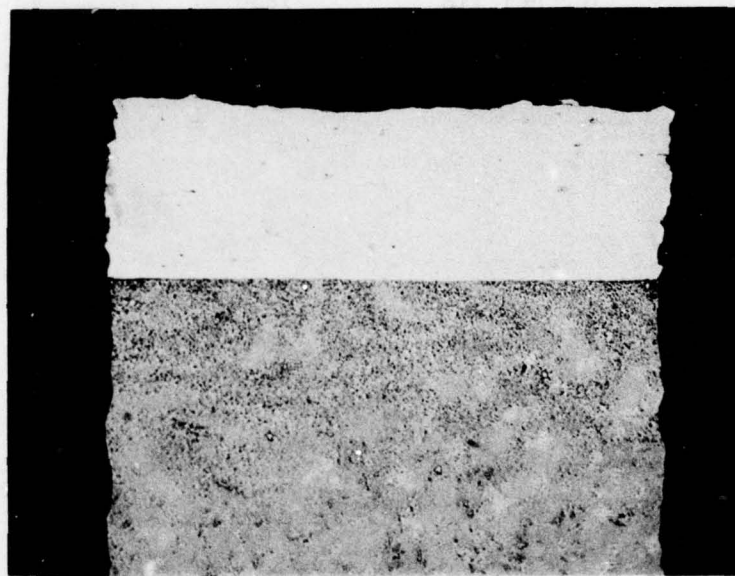
Figure 39. As-Bonded CSDB Shear Specimen Failure.

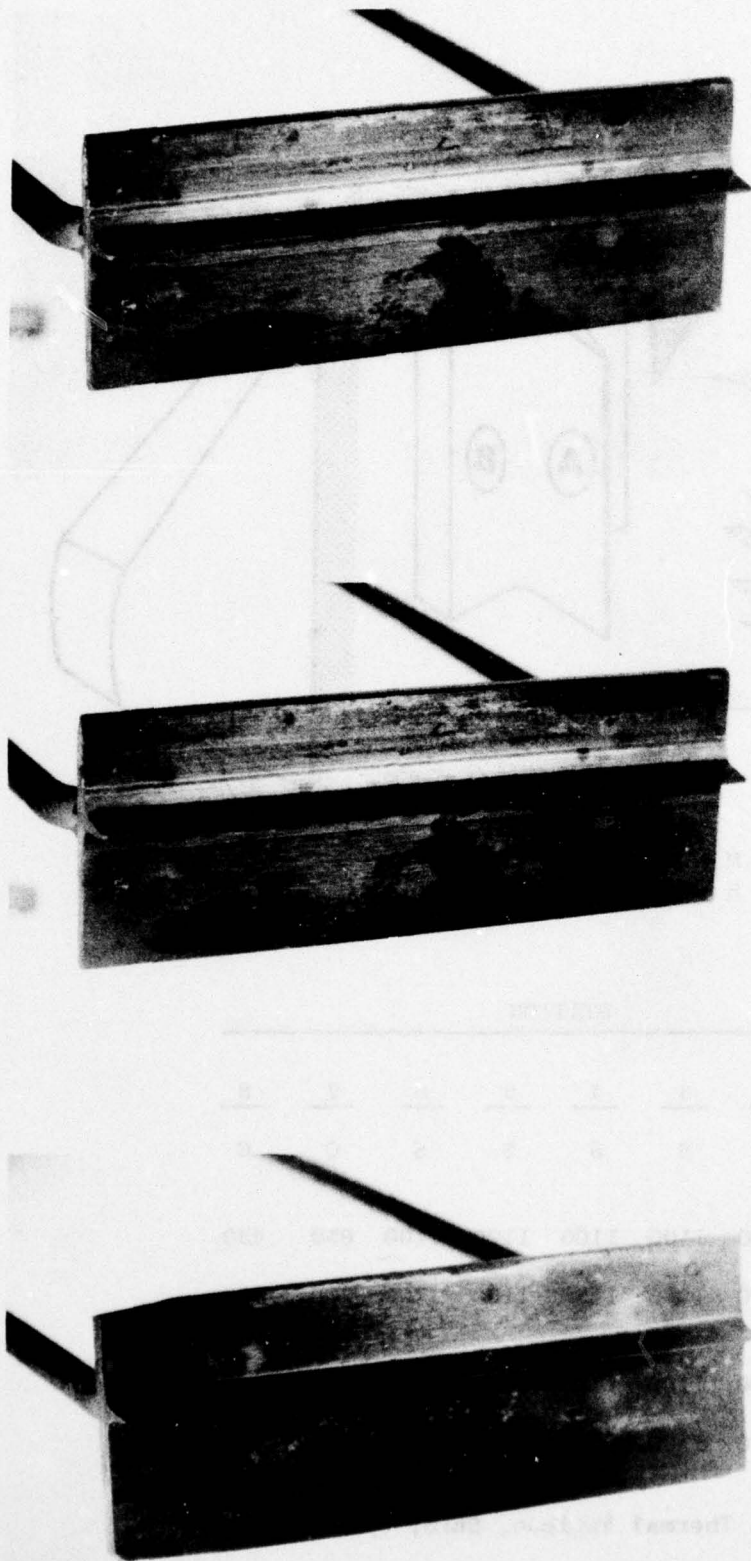
Figure 41. Thermal Fatigue, SETS, Specimens.

Right: Aged CSDB

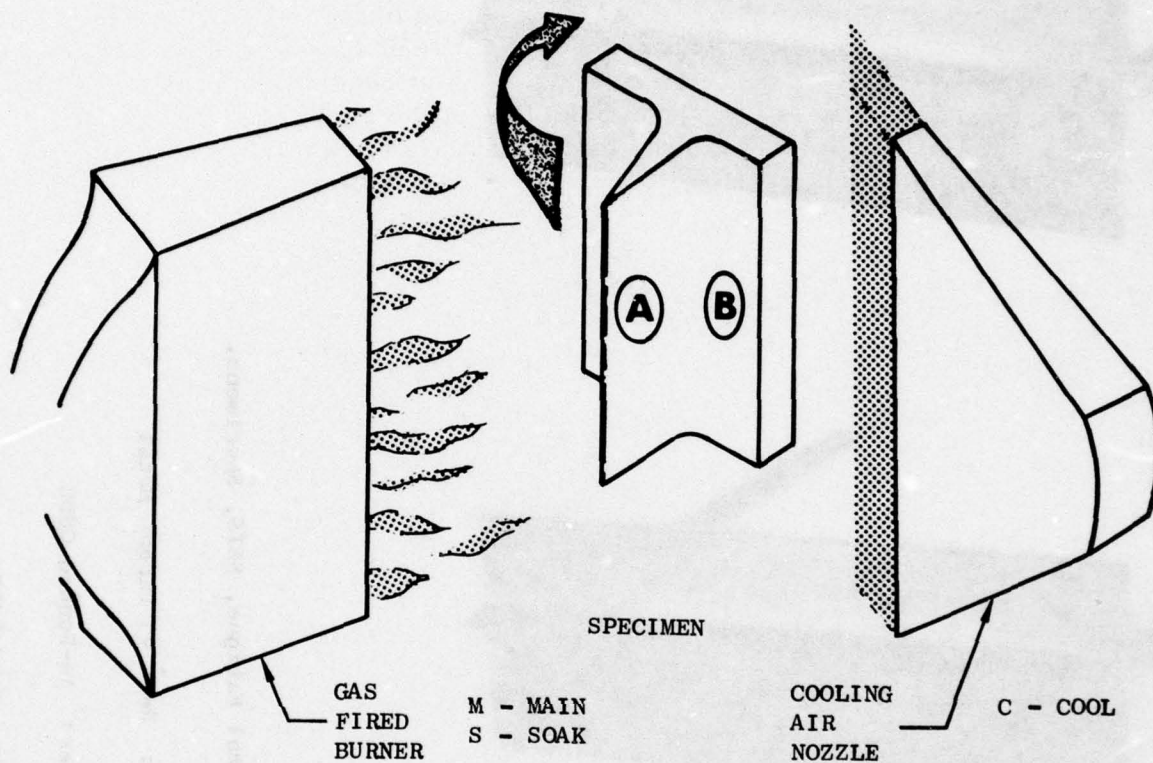
STATION							
		1	2	3	4	5	6	7	8
CYCLE		M	S	S	S	S	S	C	C
I	A	1100	1100	1100	1100	1100	1100	650	450
	B	980	1130	1090	1130	1100	1100	700	480
II	A	1100	1100	1100	1100	1100	1100	425	80
	B	970	1120	1100	1120	1100	1110	475	85

Figure 42. Thermal Fatigue, SETS, Cycles.

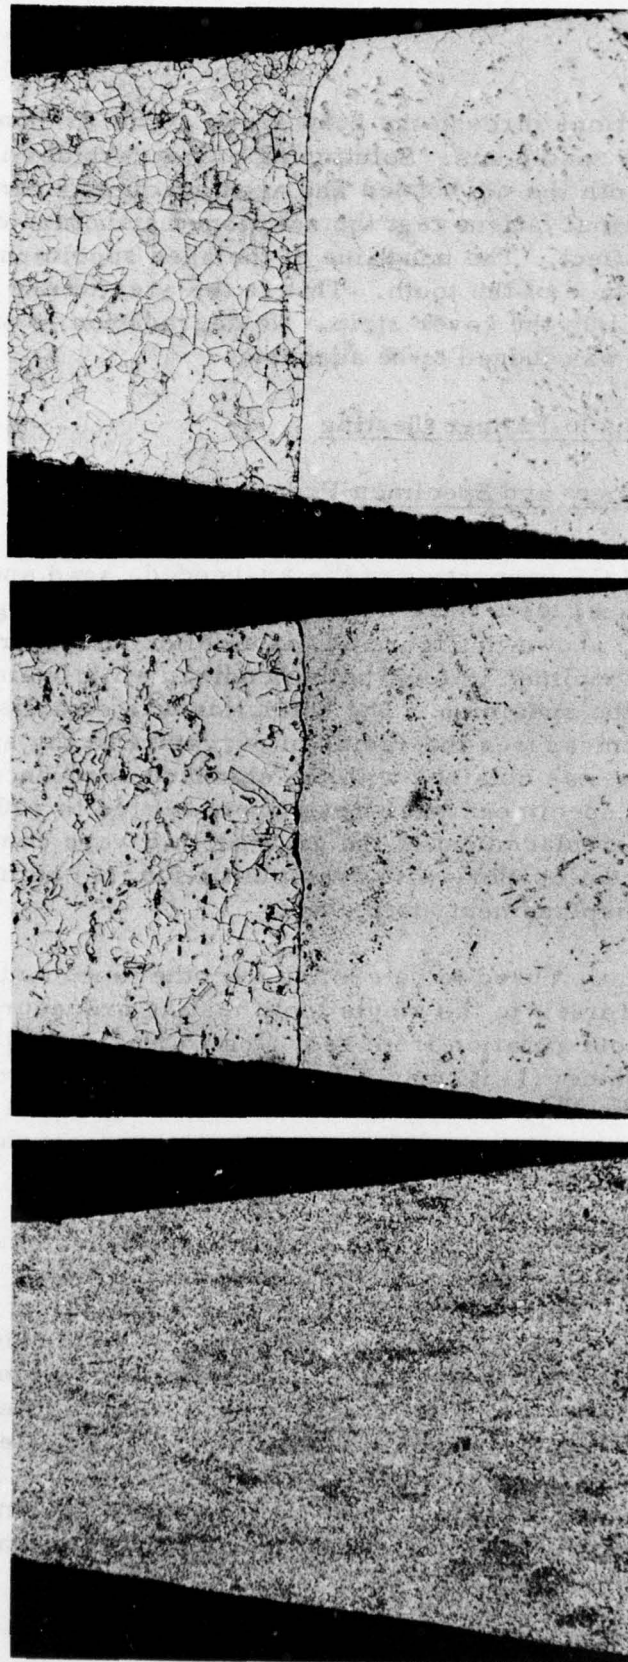
Figure 43. Sections Through Thermal Fatigue, SETS, Specimens.

Bottom: Aged CSDB

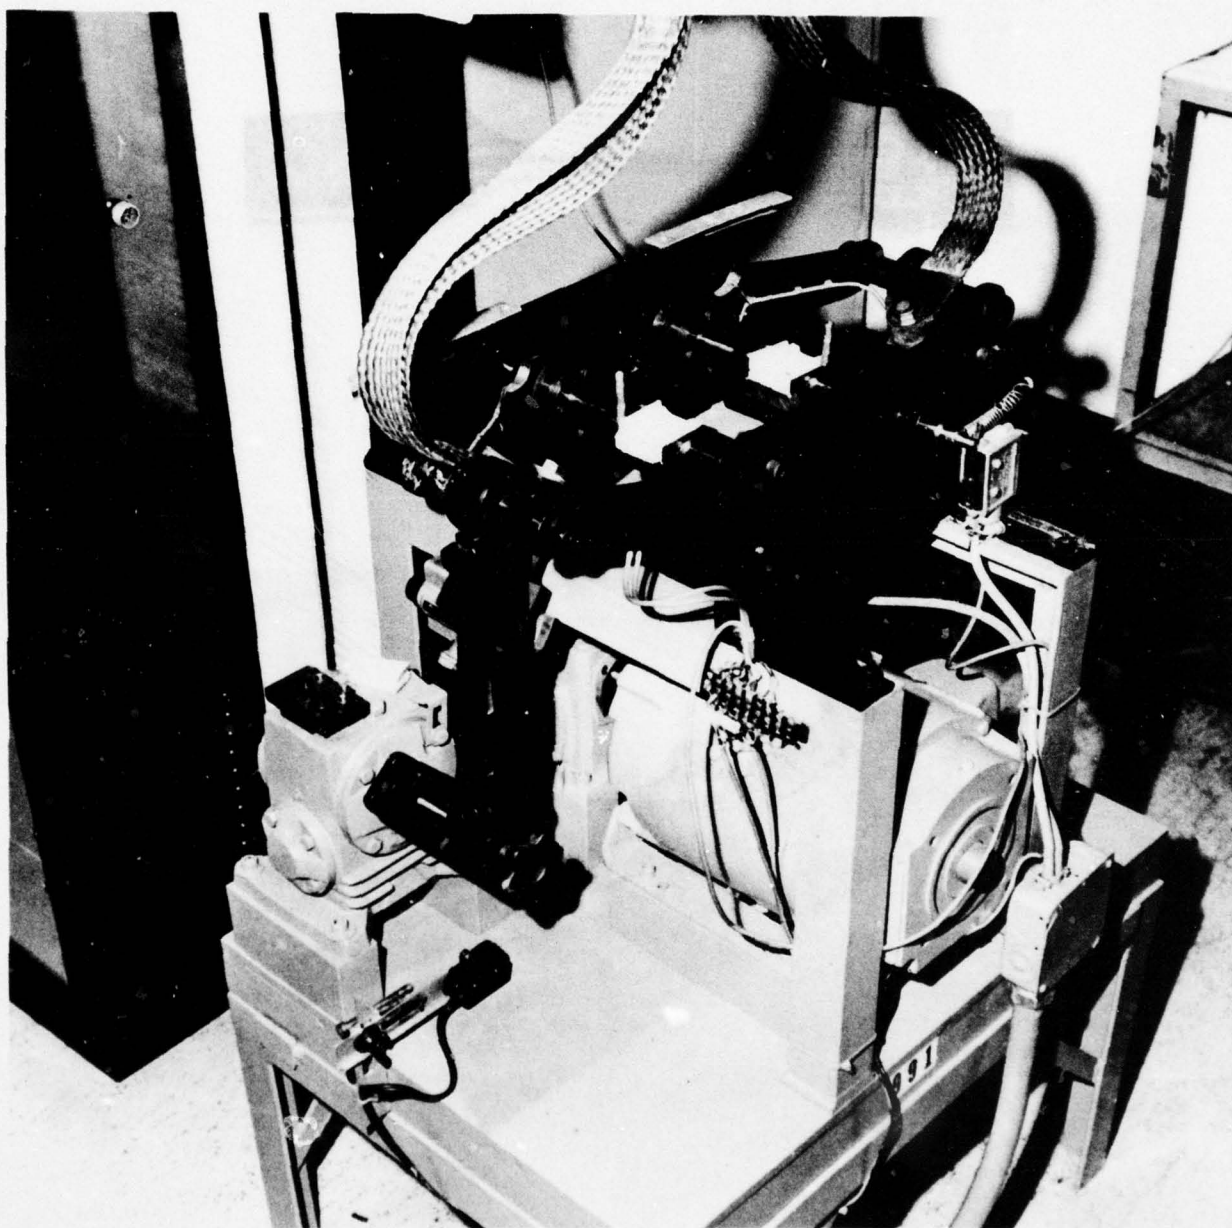
Figure 44. Forrester Four Point Bending LCF Machine.

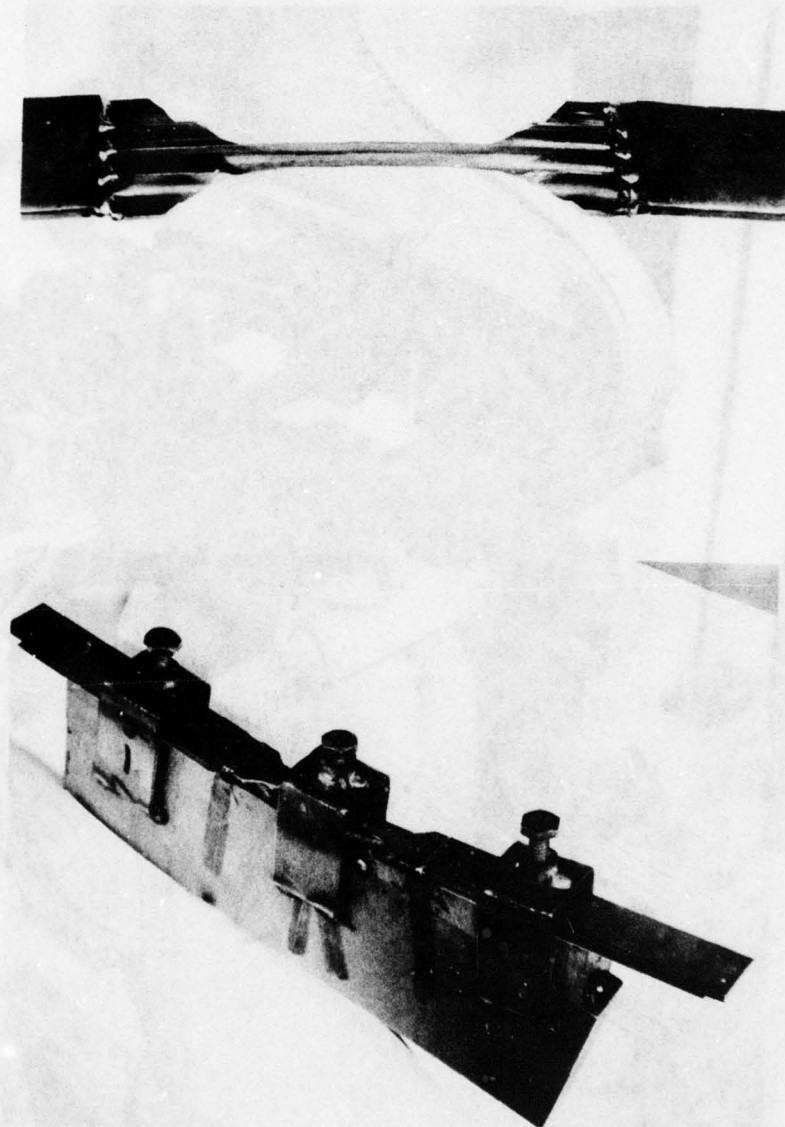
Figure 45. CSDB LCF Specimen.

Top: Specimen Cut From Seal Ring #5

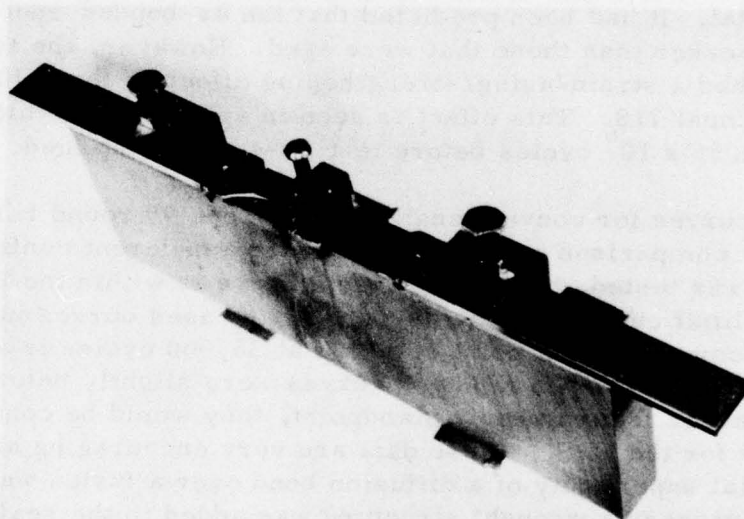
Figure 46. René 95 LCF Specimen.

Top: Specimen Machined From Plate

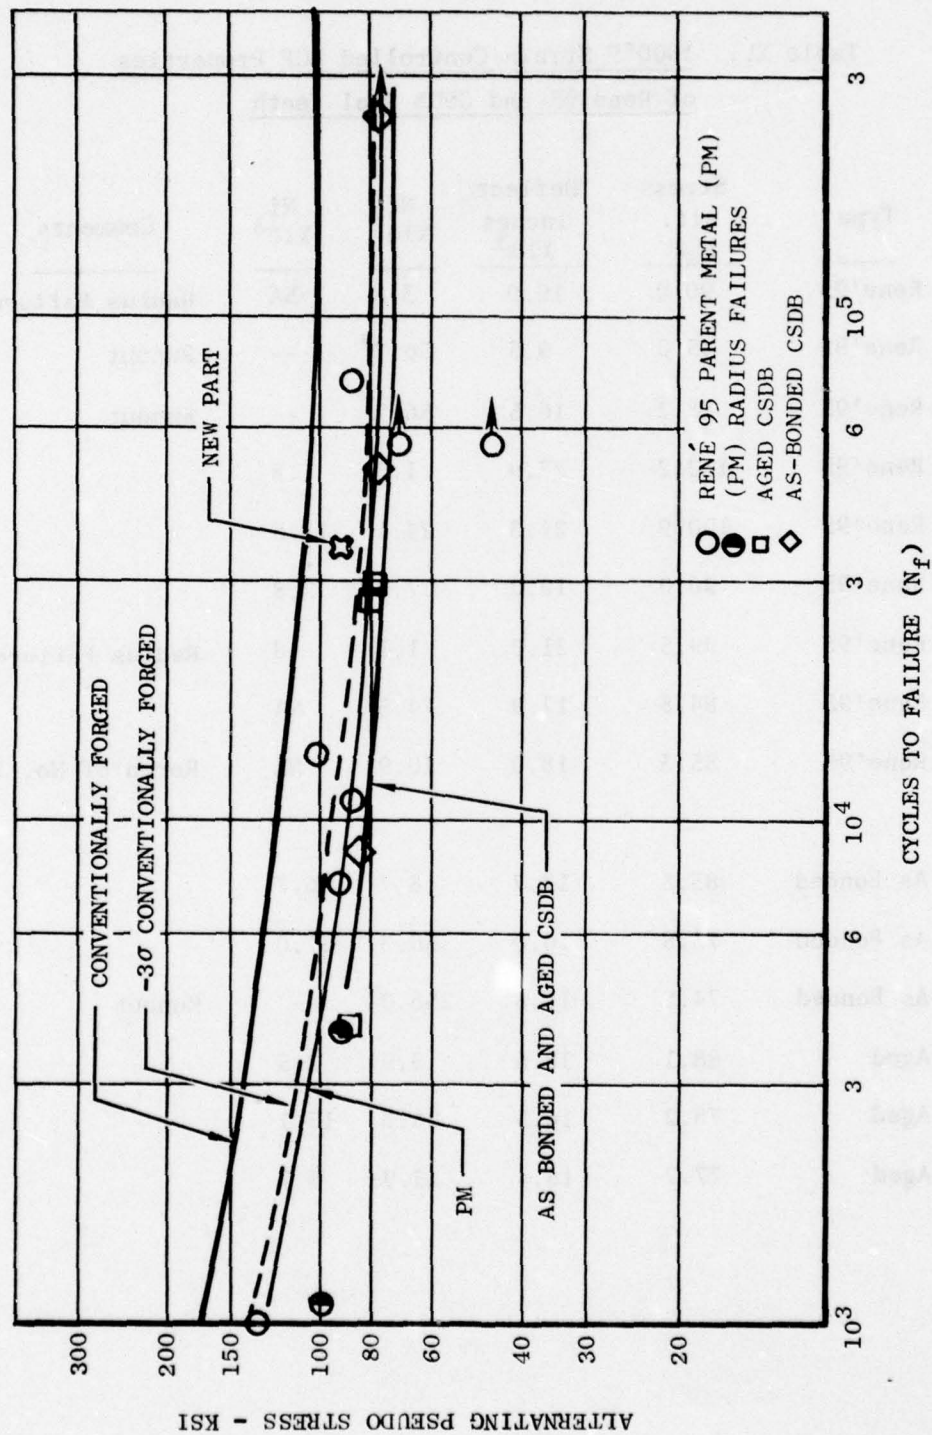
Figure 47. 1000°F LCF Properties of Seal Teeth Specimens ($A = .95$, 20 CPM).

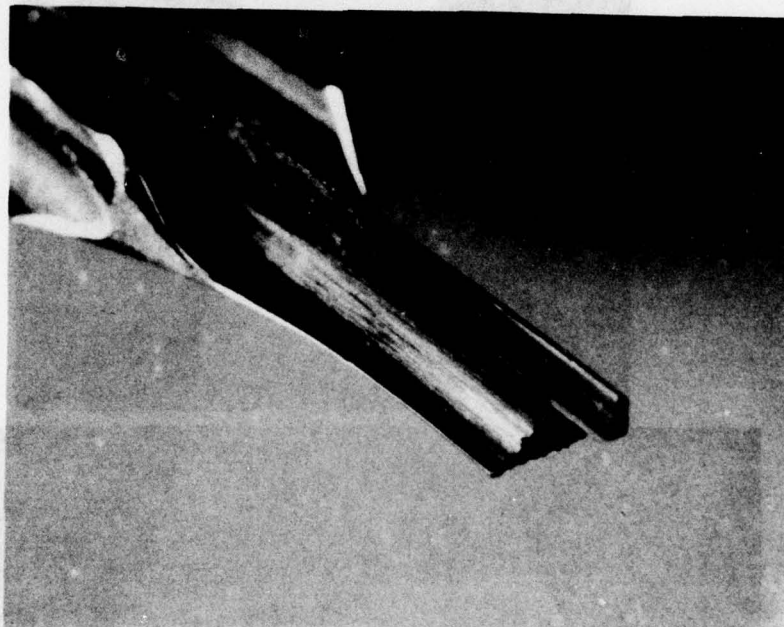
Figure 49. Failure Mode of Aged CSDB LCF Specimens.

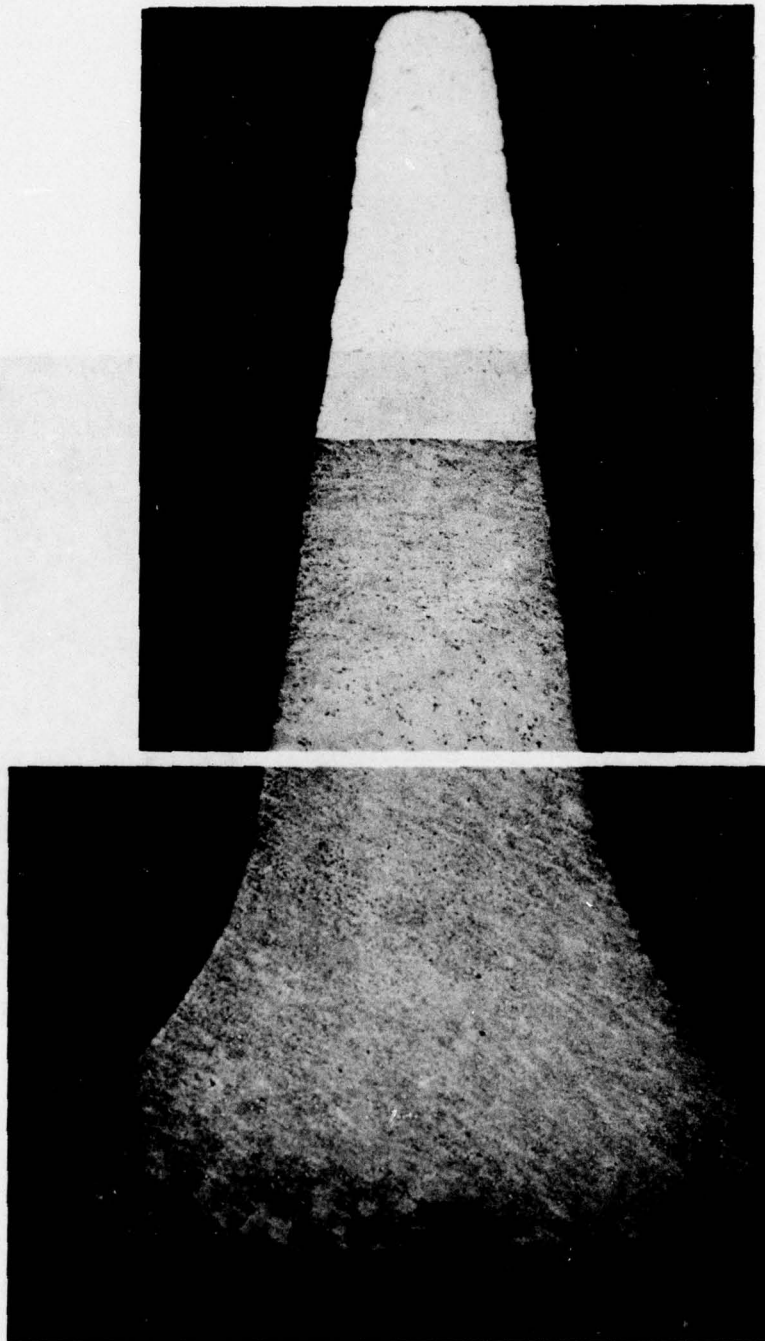
Figure 50. Cross Section of Center Tooth of Seal Ring #5 at Location X-3.
